# ***New Trend Home Inspection Inc.***

## ***Home Inspection Report***

414 Anywhere St, Toronro

Inspection prepared for: John Doe  
Date of Inspection: 11/9/2012 Time: 10.00 am  
Age of Home: 80-100 Size: 2000

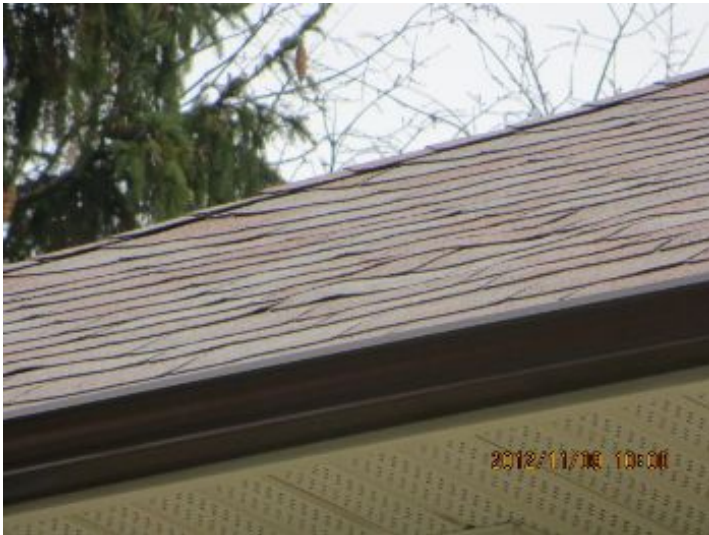
Waviness/Uneven roof surface appeared in most area of the roof. This is relatively a common condition and can be result of inadequate ventilation or water damage. At:

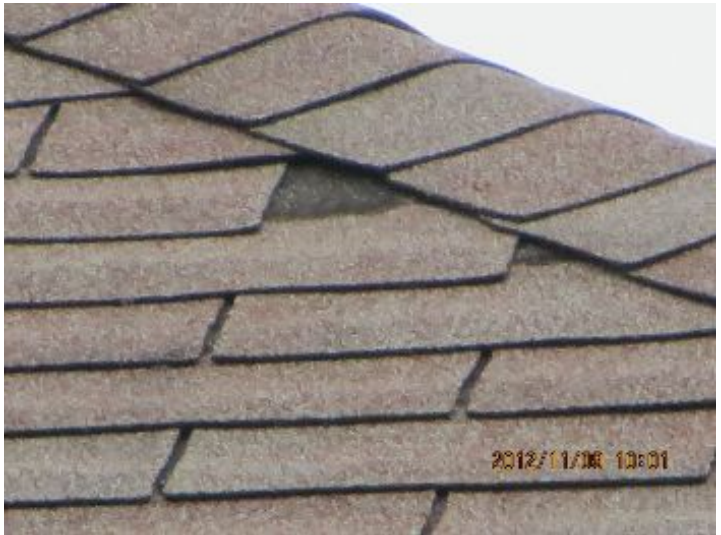
Missing shingle(s) in noted.

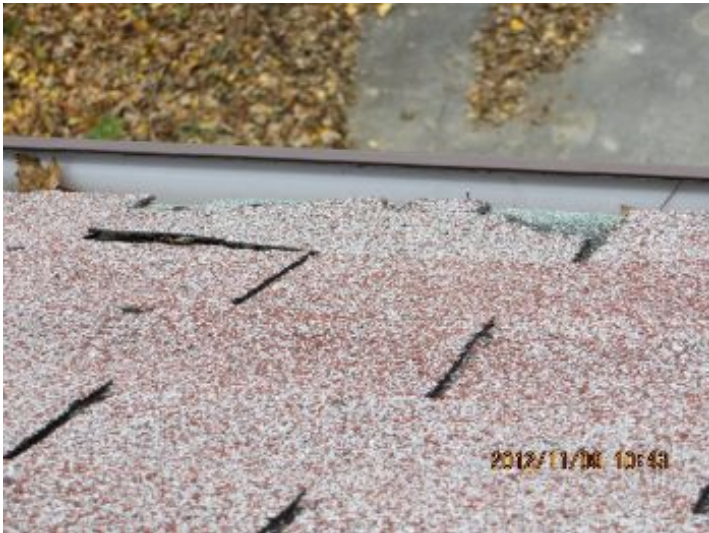
Lifting at laps and around roof vents observed.

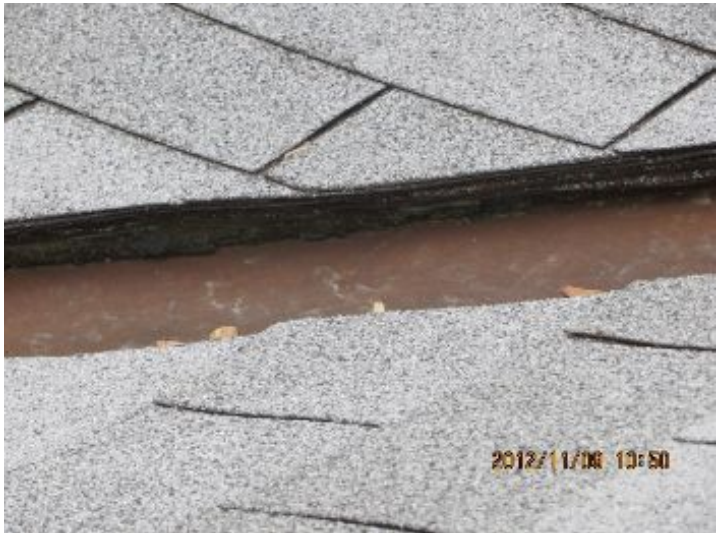
2 or more layers of shingles observed.

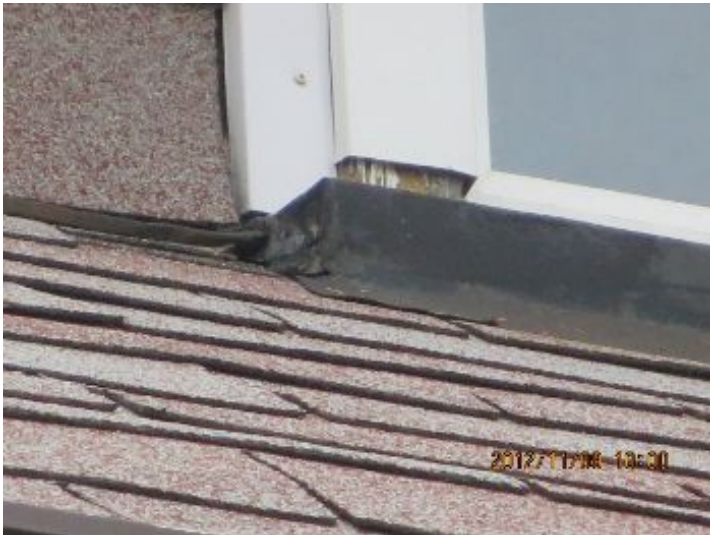
Flashing are original, recommend resealing/maintaining all flashings and through the roof vents as a part of routine maintenance. Recommended to be replaced in next roofing project.

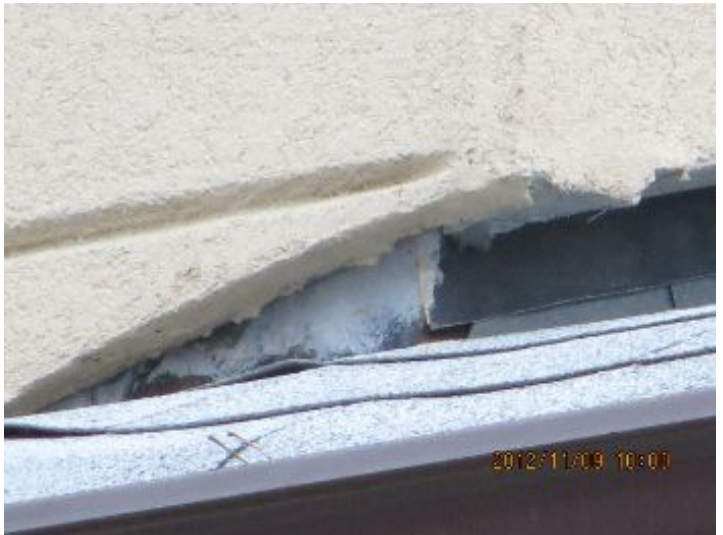
Missing kick out flashing. Installation proper kick out flashing is required.

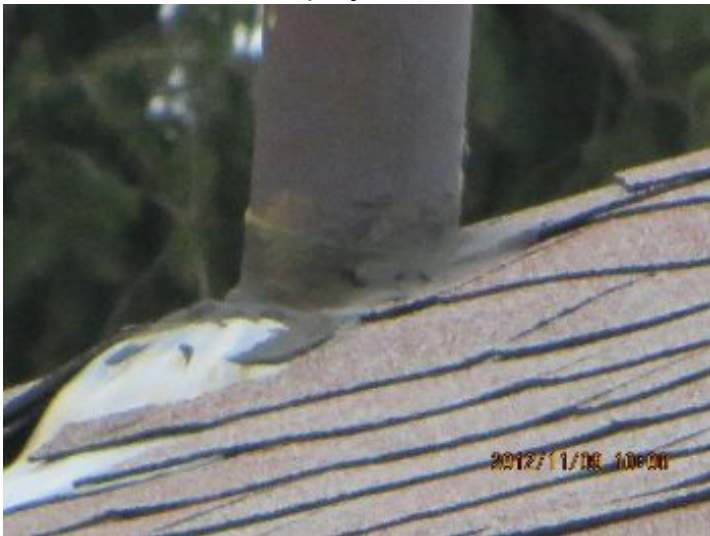
Roof vent(s) is not properly installed. nailing and caulking is required.

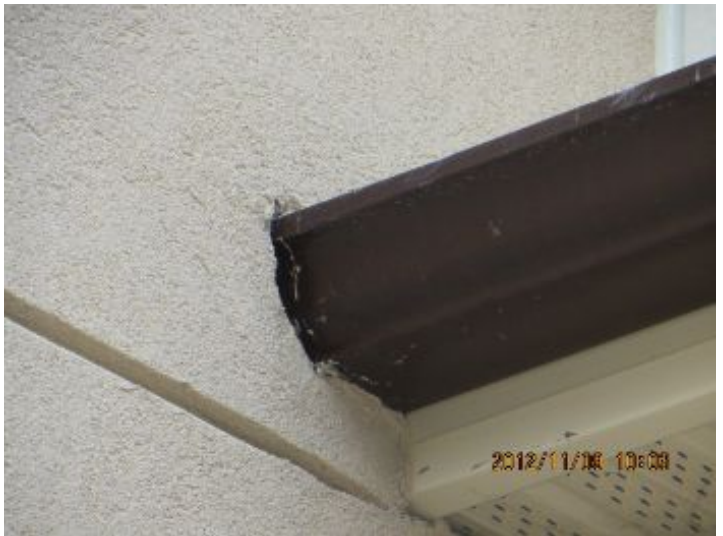
Missing kick out flashing. Installation proper kick out flashing is required.

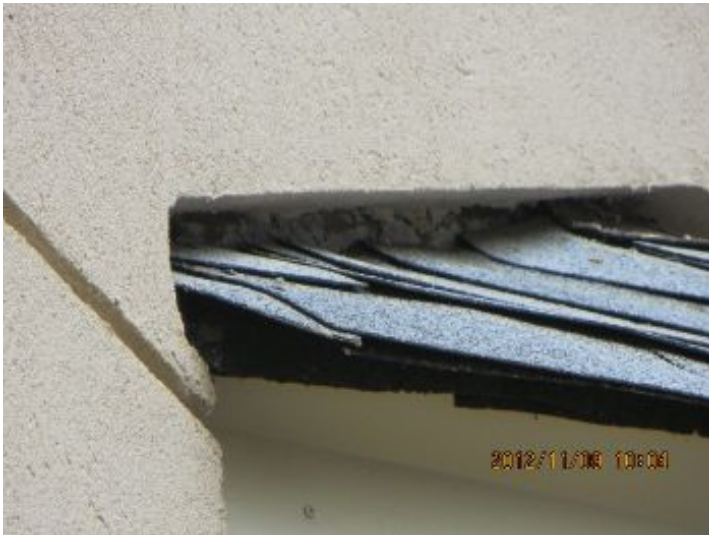
Missing counter flashing. Installation proper counter flashing recommended.

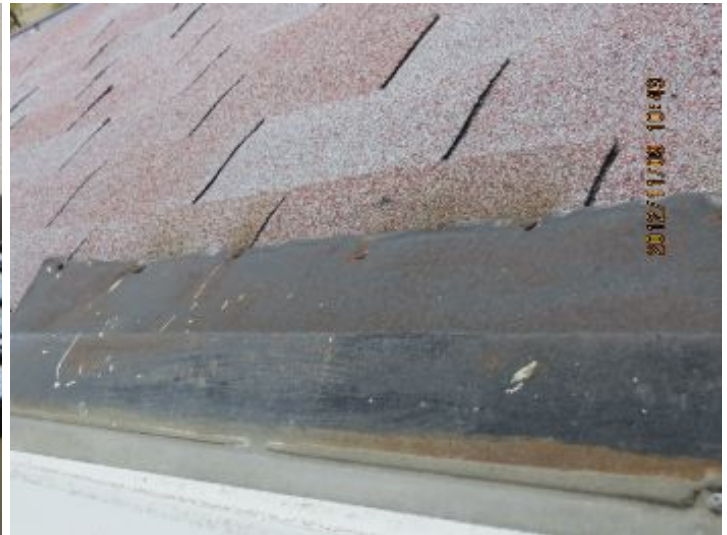
Flashing are original, recommend resealing/maintaining all flashings and through the roof vents as a part of routine maintenance. Recommended to be replaced in next roofing project.

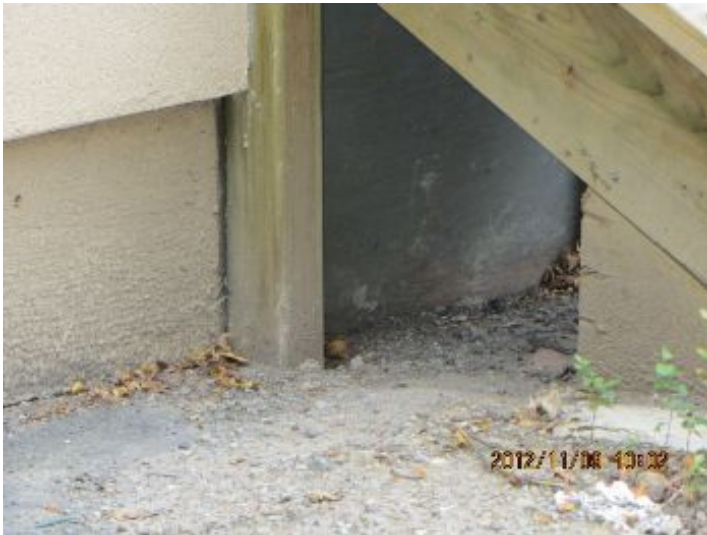
Evidence of ponding observed. At: rear

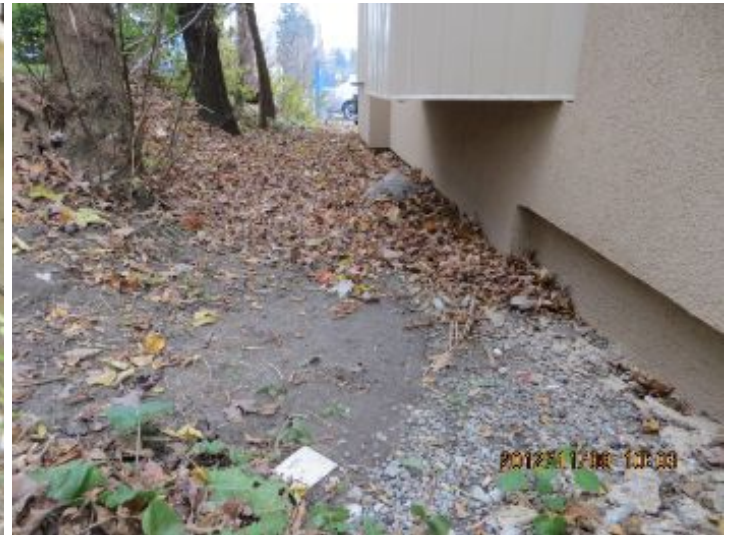
Sidewalk is pitched towards the structure, this may result in basement seepage. At east and rear

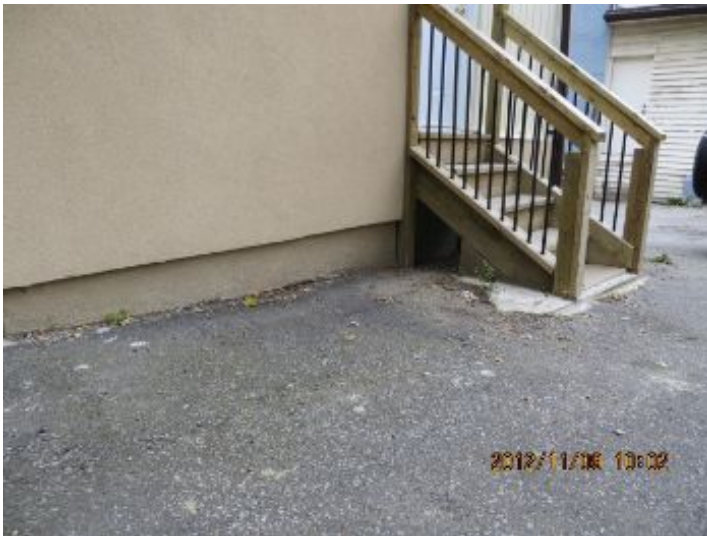
Grading slopes toward the foundation walls. Correction/improvement is needed. at: rear and east

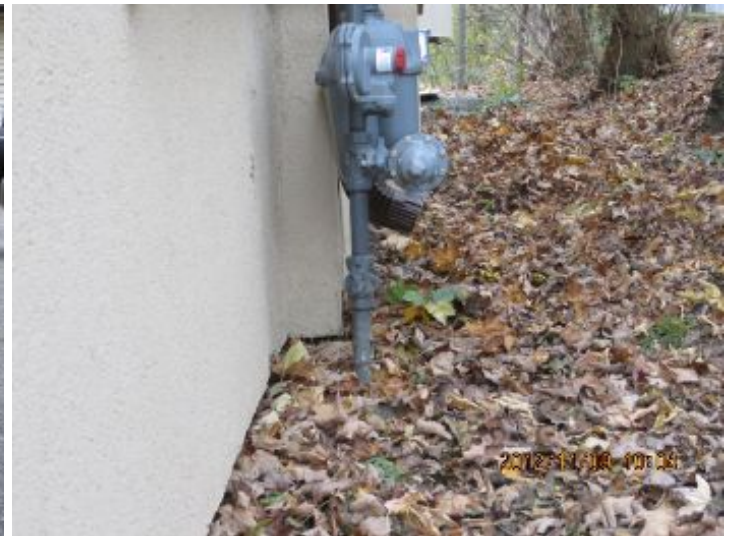
Grading slopes toward the foundation walls. Correction/improvement is needed. at: rear and east

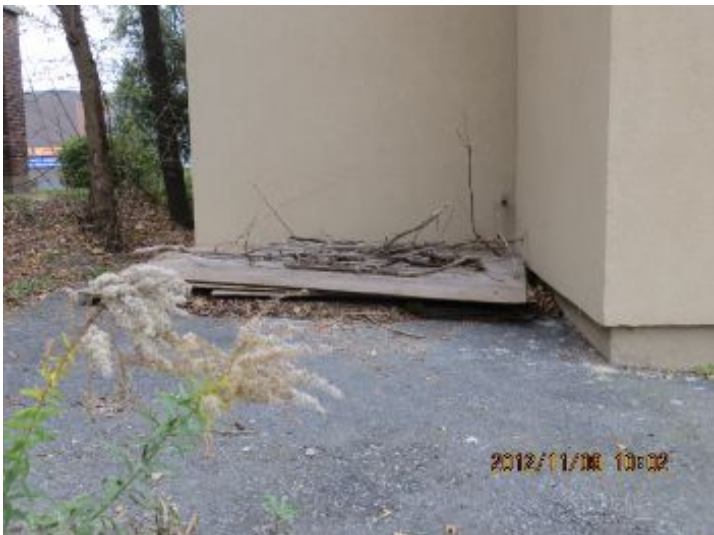
inaccessible (covered by material)At: all around

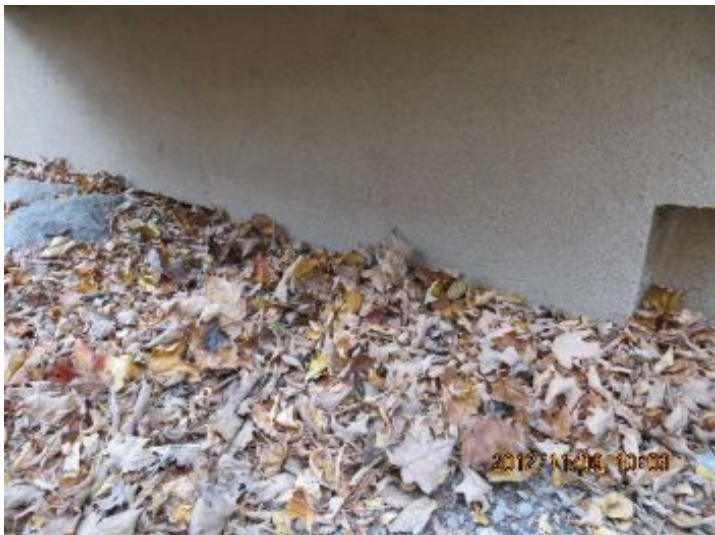
Brick to earth contact noted. This can result in water penetration & brick "spalling" or deterioration over time. Re-grading or other protection of brick is recommended. Foundation wall should extended Min 6" above finished grading. At: front

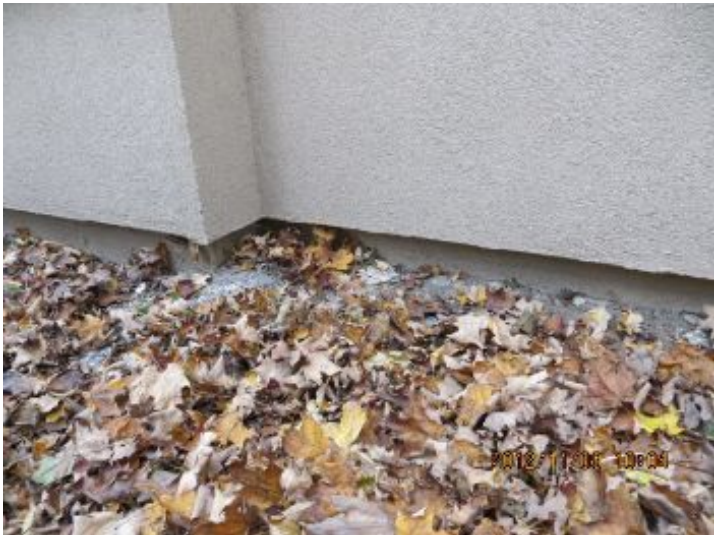
inaccessible (covered by material)At: all around

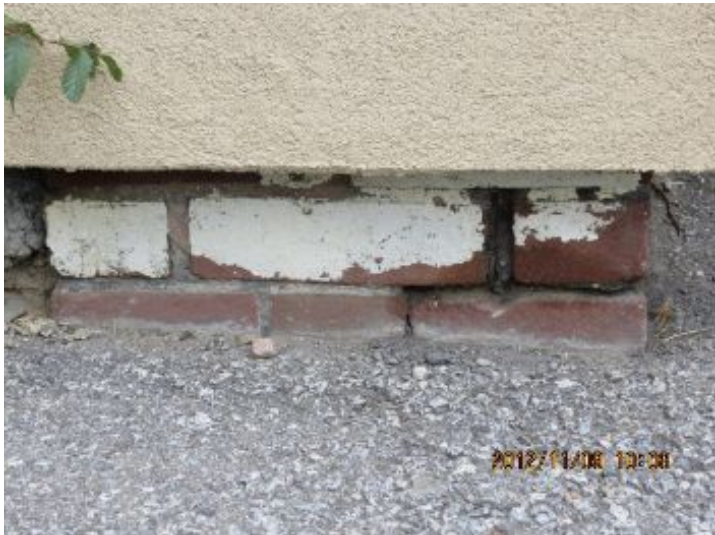
Brick to earth contact noted. This can result in water penetration & brick "spalling" or deterioration over time. Re-grading or other protection of brick is recommended. Foundation wall should extended Min 6" above finished grading. At: front

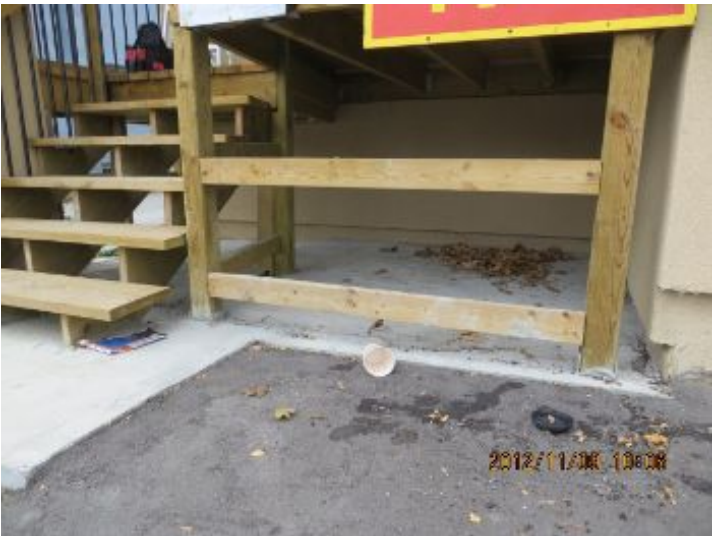
Improper installation of column to pilar, lack of proper bracket or hanger was appeared.  
This situation is structure not supported, installation proper bracket to improve deck structure is required.

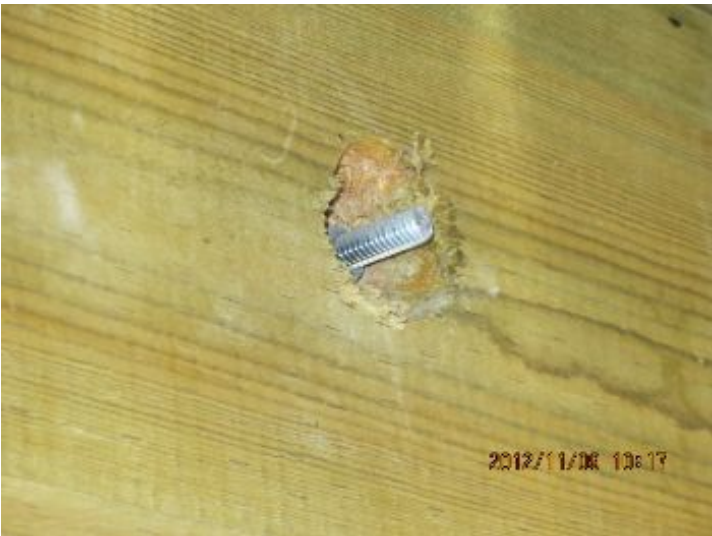
Deck appears to be nailed to the structure or anchor bolt has been used into veneer, which is not meet today building code, through out Bolts secured to the house framing are required by most municipalities. We recommend reviewing local standards for safety and compliance. further check is required.

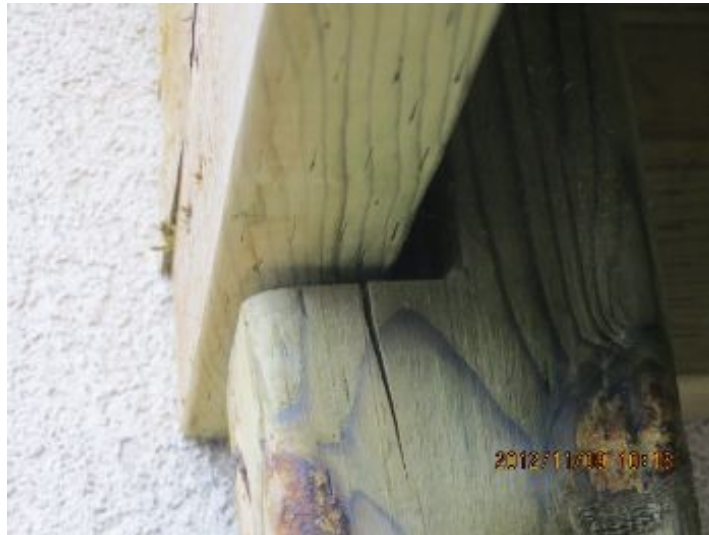
Installation joist hanger and proper bracket is required, this condition does not meet today's building code. recommend review by a qualified professional for repair or replacement as necessary.

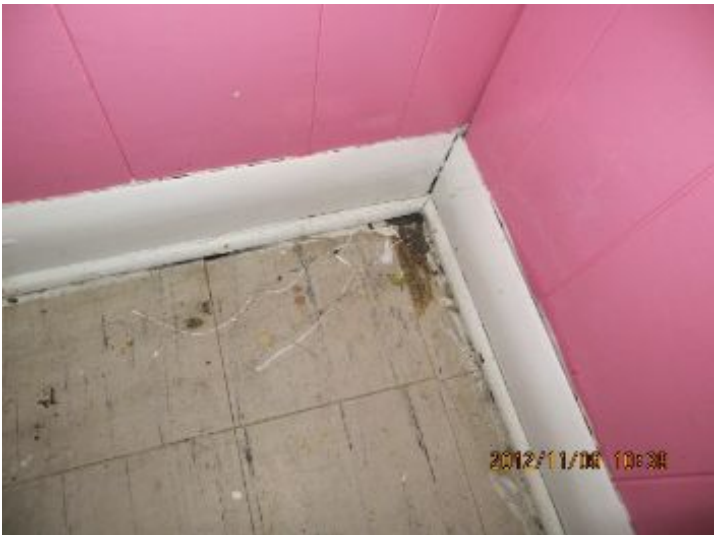
Wood rot, moisture damage observed

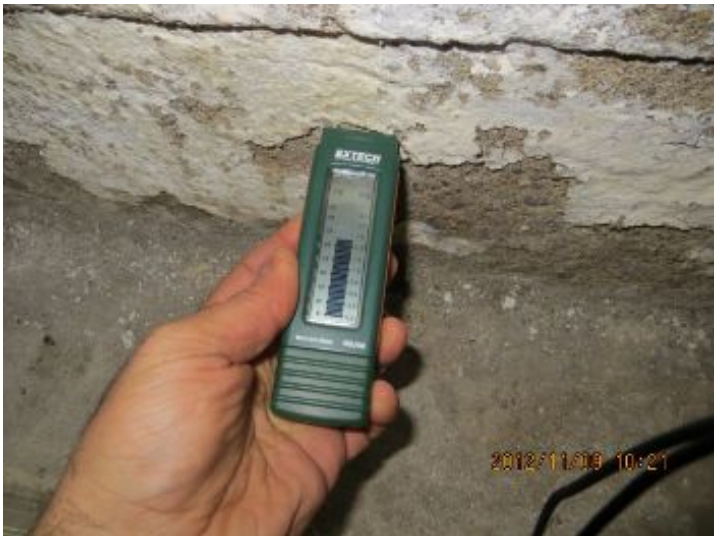
Active leaks observed at the time of inspection.

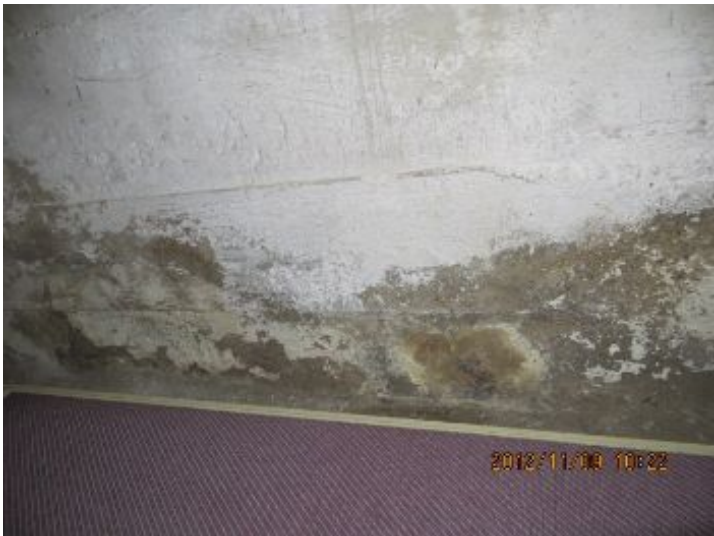
Efflorescence observed; this is a mineral deposit left behind from exterior water infiltration.

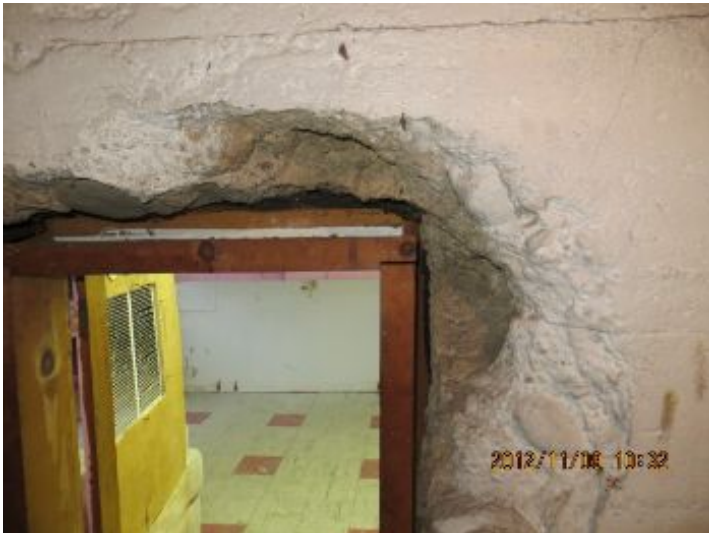
Foundation wall(s) have been cut or bored. The foundation wall is not structurally supported. Instalation proper lintel is required.

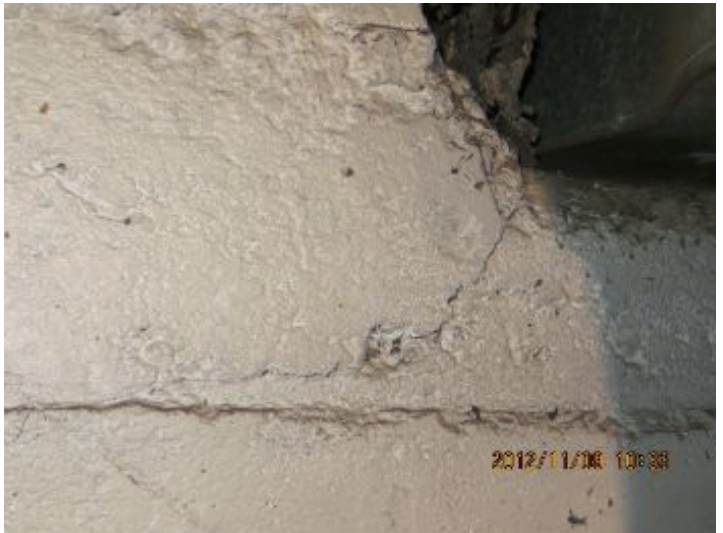
Structural crack(s) is noted. This type of crack should been assess by qualified contractor or structural engineer.

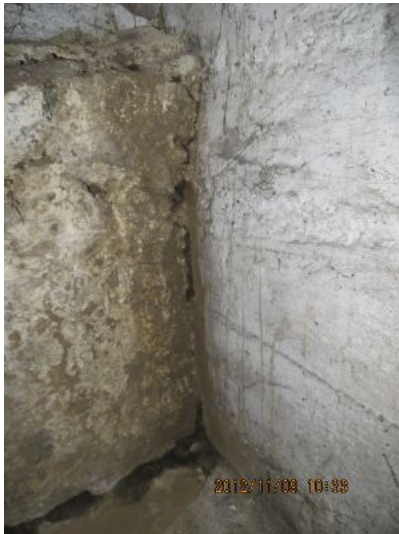
Active leaks observed at the time of inspection.

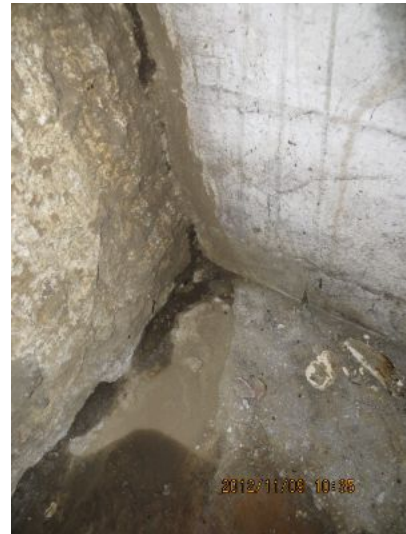
Active leaks observed at the time of inspection.

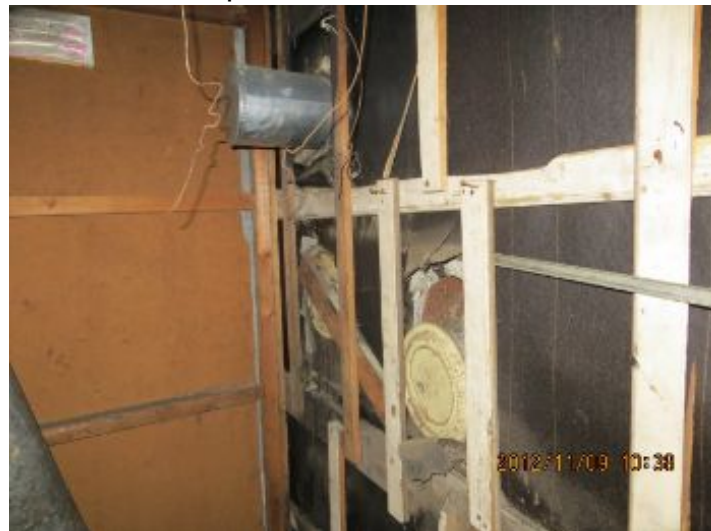
unsecured holes in exterior walls is observed. Should have been repaired.

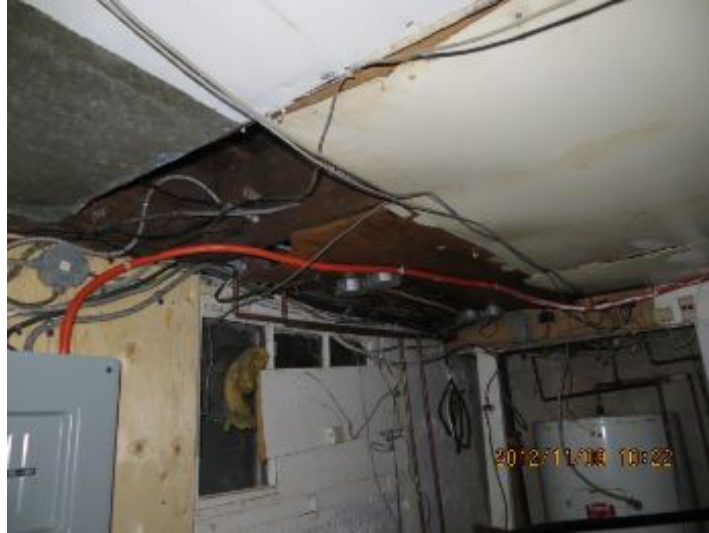
Ceiling is sagging.

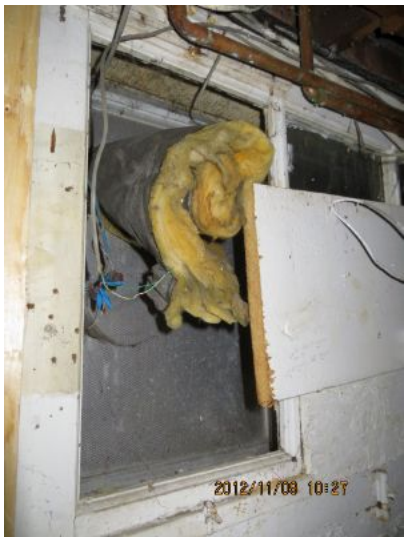
Some or all windows were blocked with materials or storage. Has to be open.

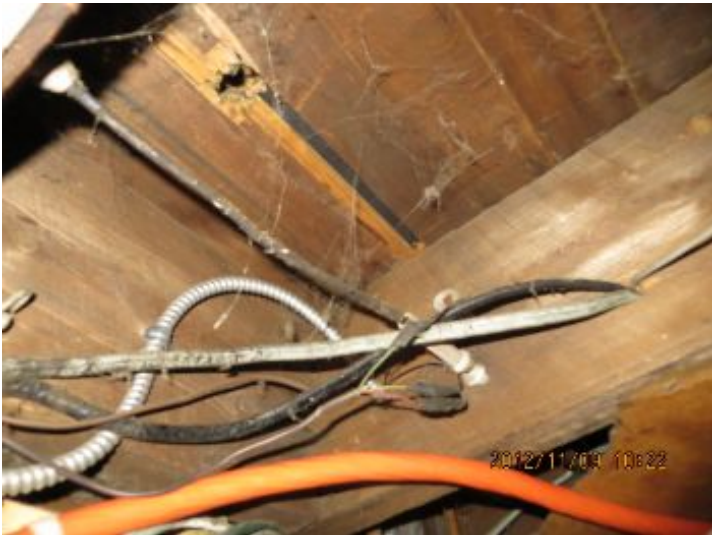
Knob and tube wiring was observed in this home. This type of wiring was standard at the time of construction, and unless otherwise noted, appears to be in serviceable condition.

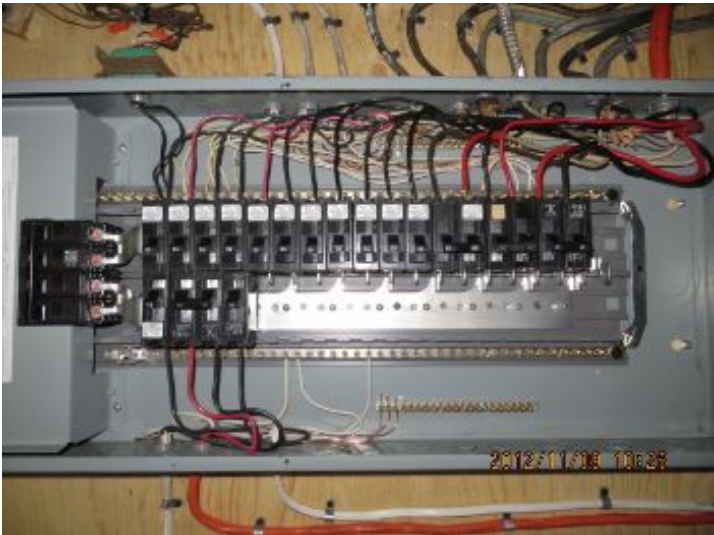
AFCI protection in bedroom branch circuits in a new requirement, not present in this house.

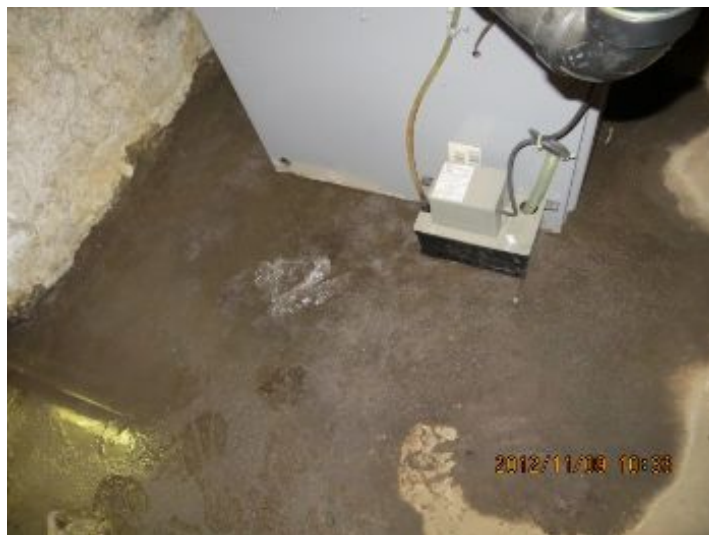
Floor drain is not installed in furnace room. Floor drain is required.

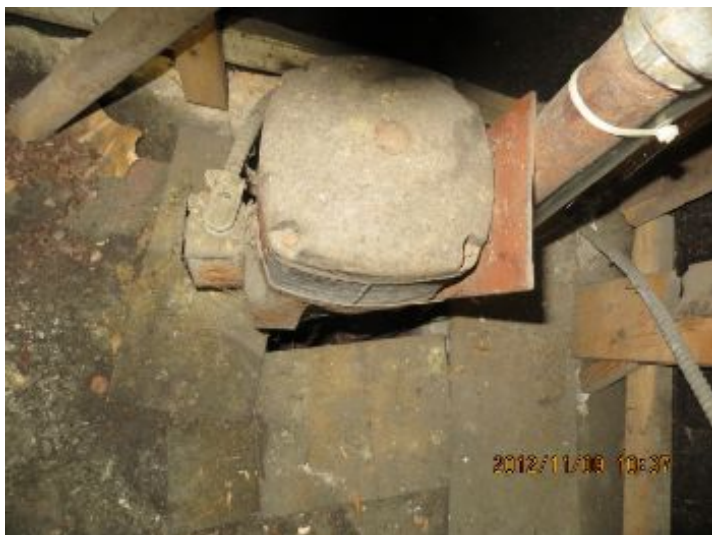
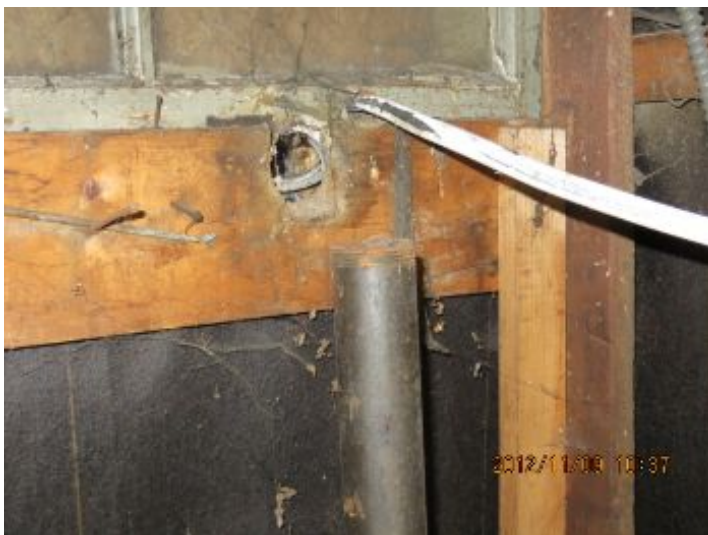
Sump pit cover is missing, suggest installing cover for safety. The discharge pipe was disconnected from sump pump.

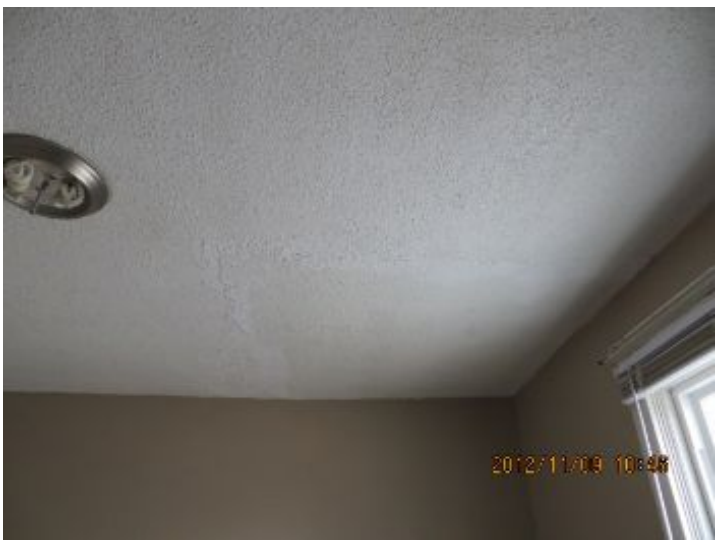
Patching observed.

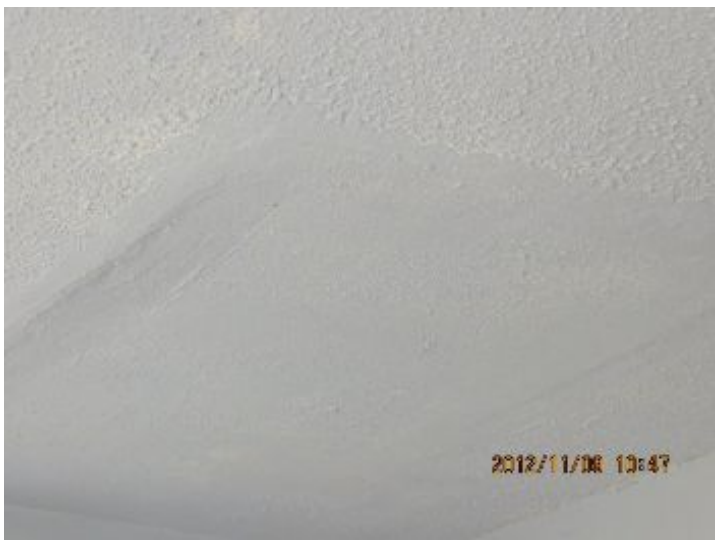
Evidence of repairs observed, unable to determine the effectiveness of these repairs. At:

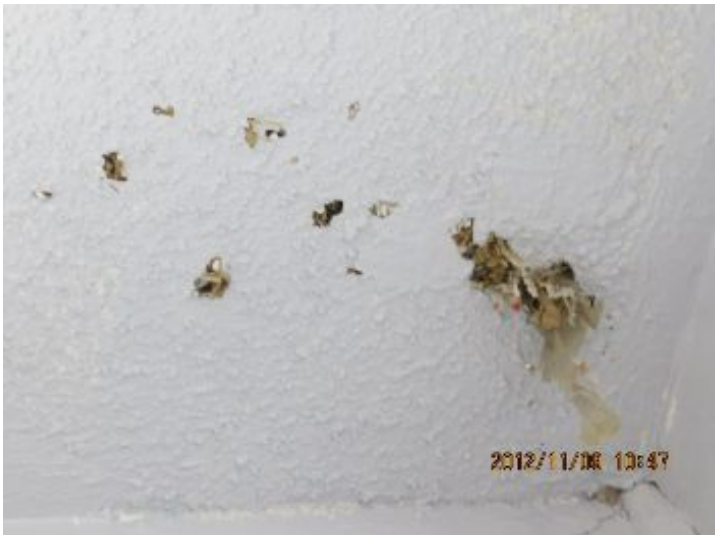
Evidence of insects.

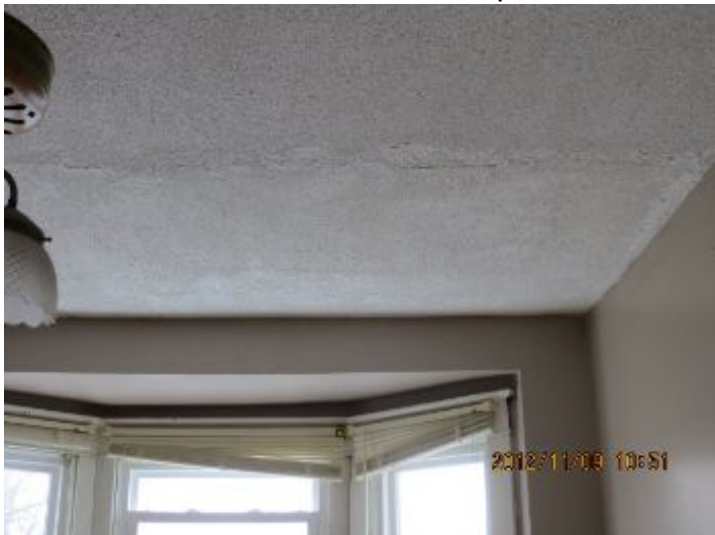
Evidence of repairs observed, unable to determine the effectiveness of these repairs. At:

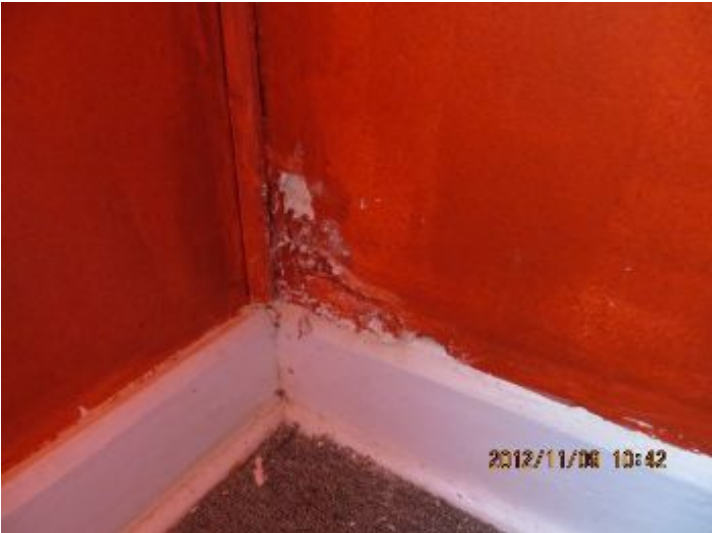
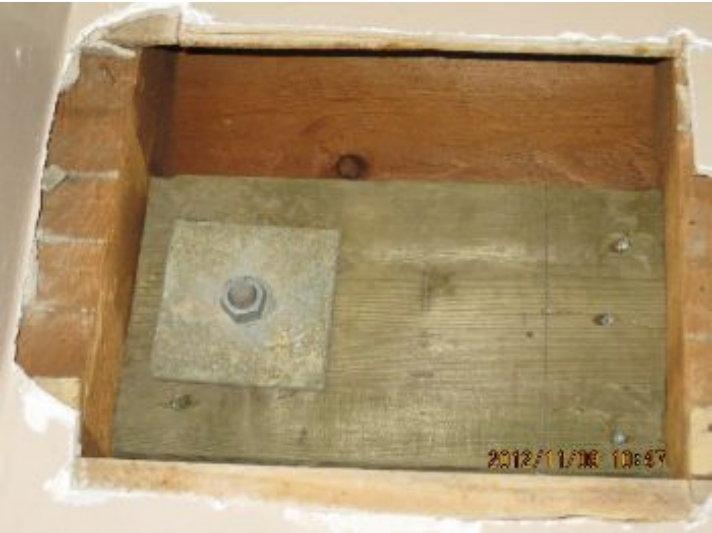
Evidence of past water penetration observed. At: Recommend review by a qualified professional for repair or replacement as necessary.

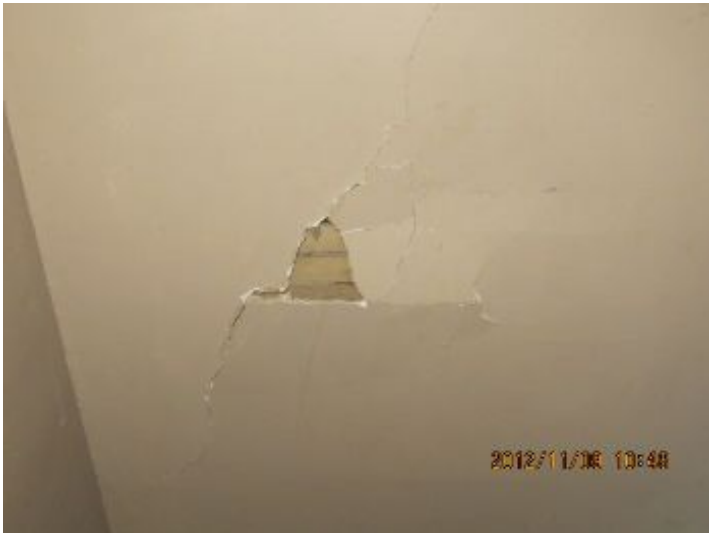
Damage(s) noted. required repair and painting.

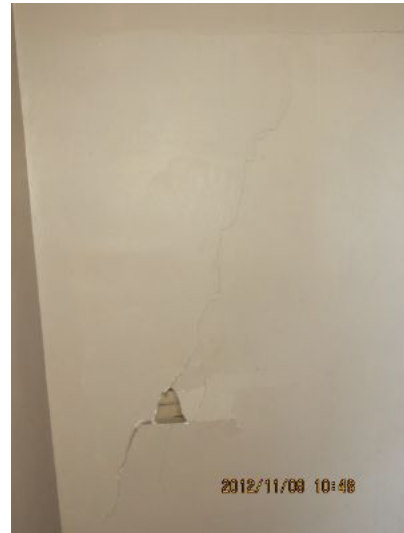
Damage(s) noted. required repair and painting.

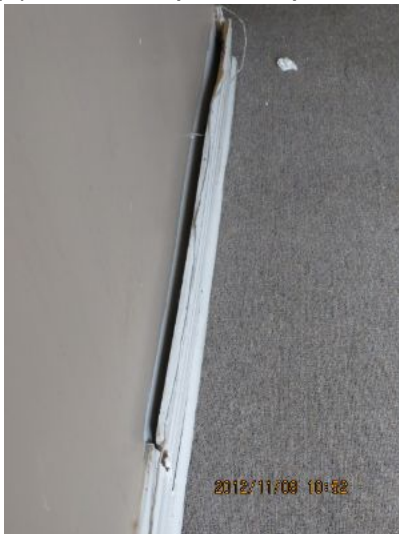
Damage(s) noted. required repair and painting.

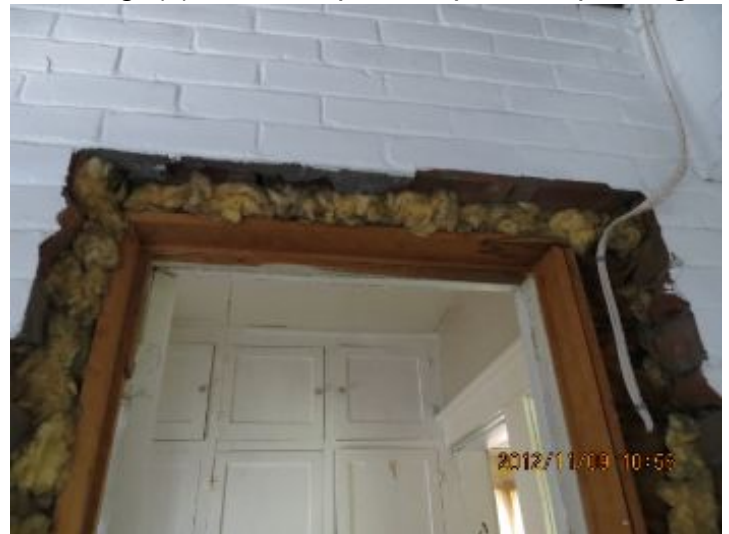
Exterior wall(s) have been cut or bored. The exterior wall is not structurally supported. Instalation proper lintel is required.

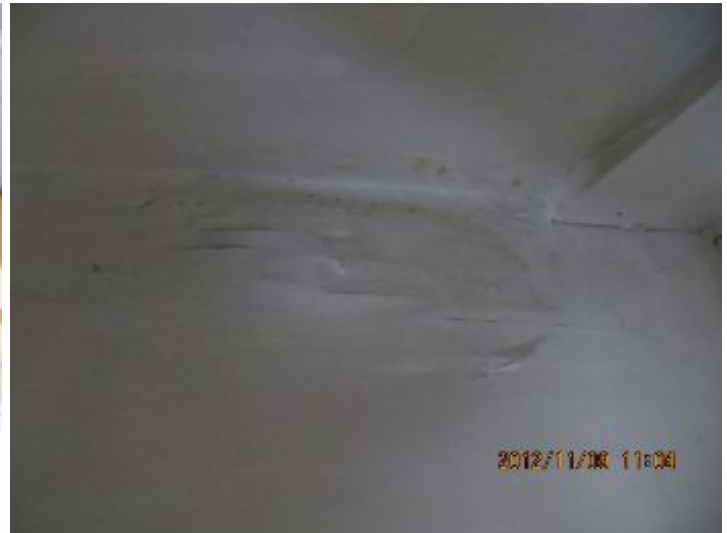
Evidence of past water penetration observed. At:

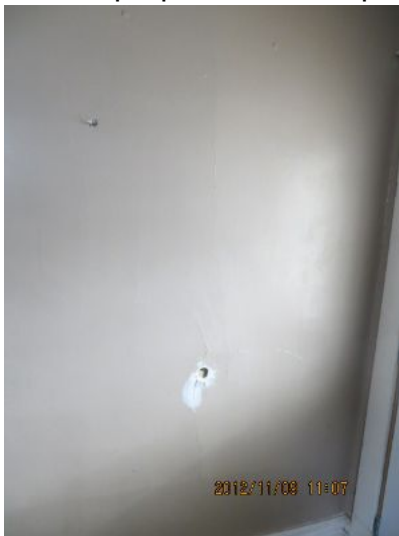
Damage(s) noted. required repair and painting.

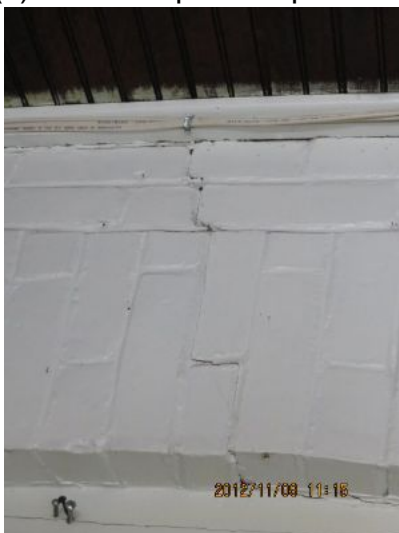
Settlement crack(s) observed. At: rear, extension part.

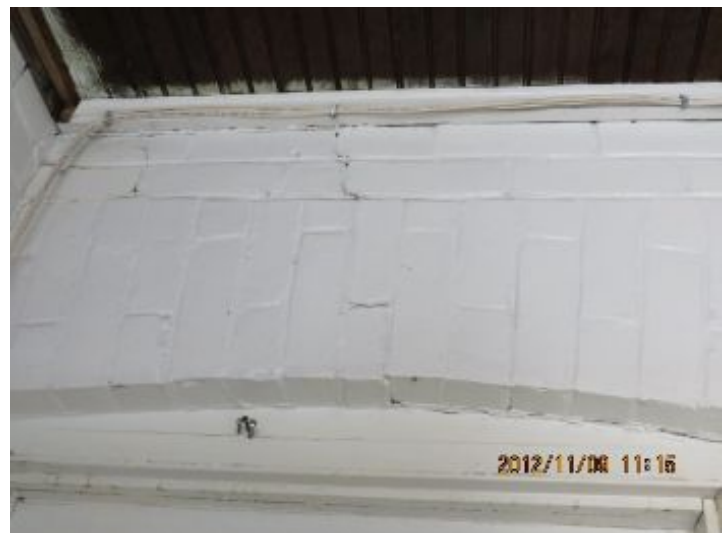
Settlement crack(s) observed. At: rear, extension part.

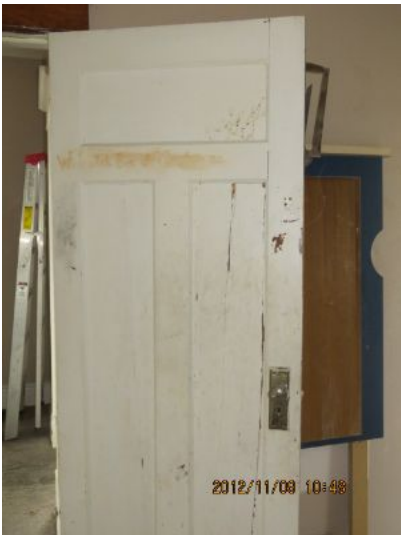
Damage(s) noted. required repair and painting.

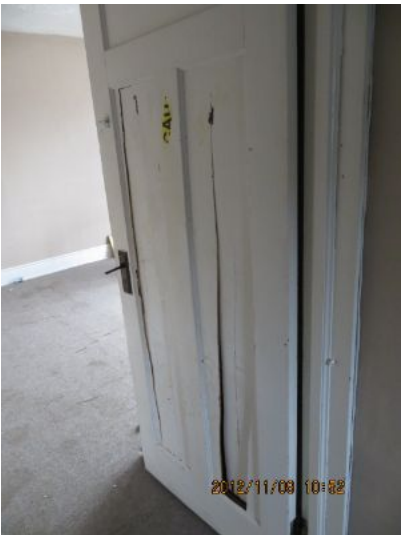
Some or most doors were broken. Required replacing.

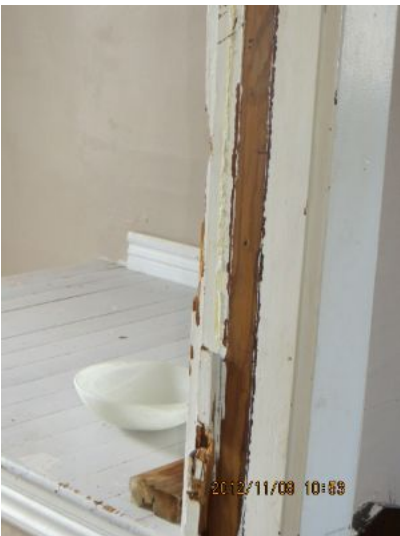
Damage(s) noted. required repair and painting.

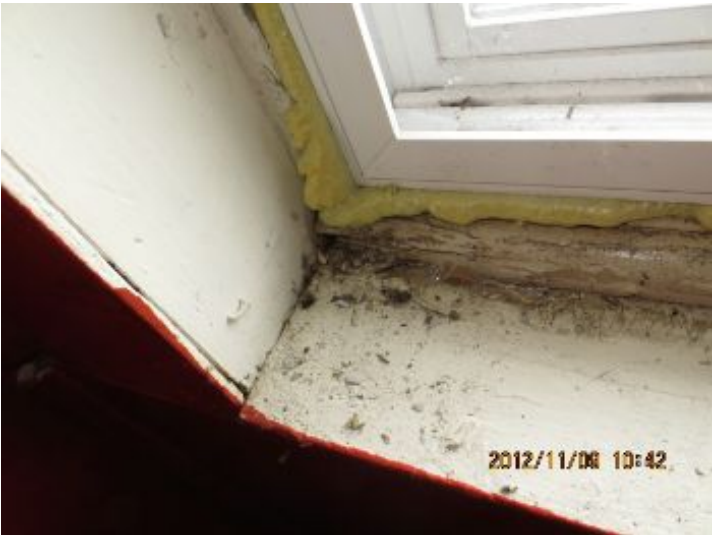
Deterioration/rot of wooden frames noted. While basic maintenance may prolong the life of these window frames, replacement may be necessary at some point.

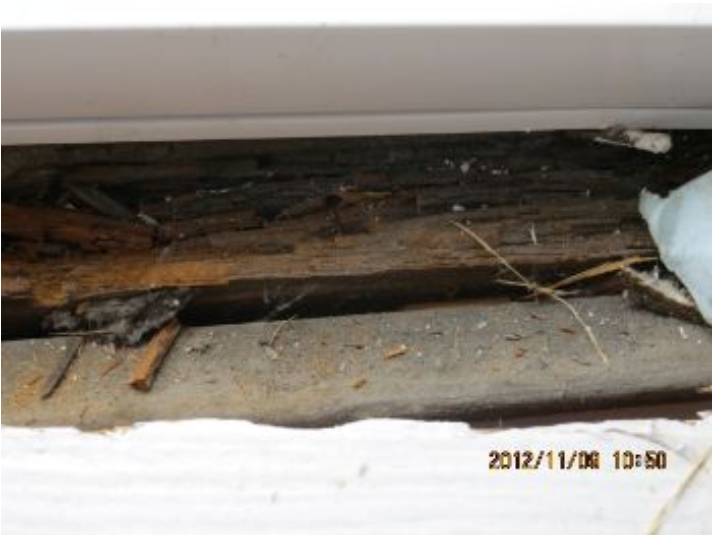
Deterioration/rot of wooden frames noted. While basic maintenance may prolong the life of these window frames, replacement may be necessary at some point.

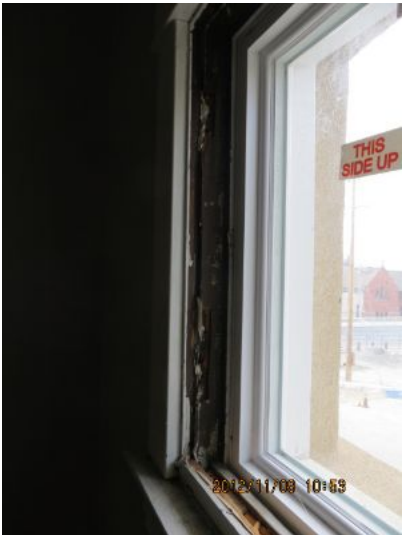
Deterioration/rot of wooden frames noted. While basic maintenance may prolong the life of these window frames, replacement may be necessary at some point.

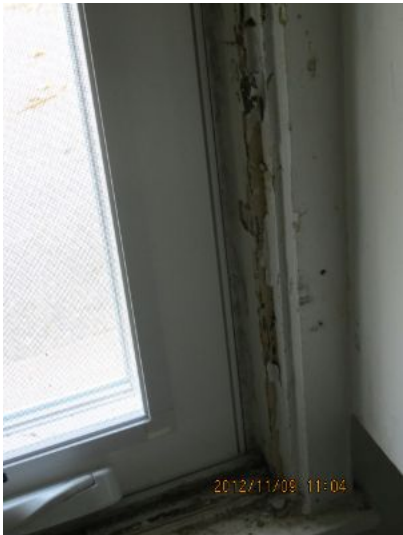
Peeling paint observed, suggest scraping and painting as necessary.

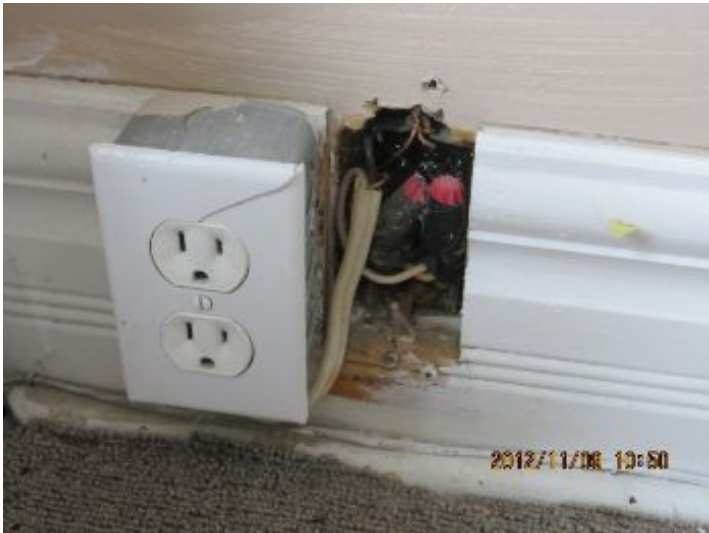
Missing cover plates observed, suggest installing for safety.

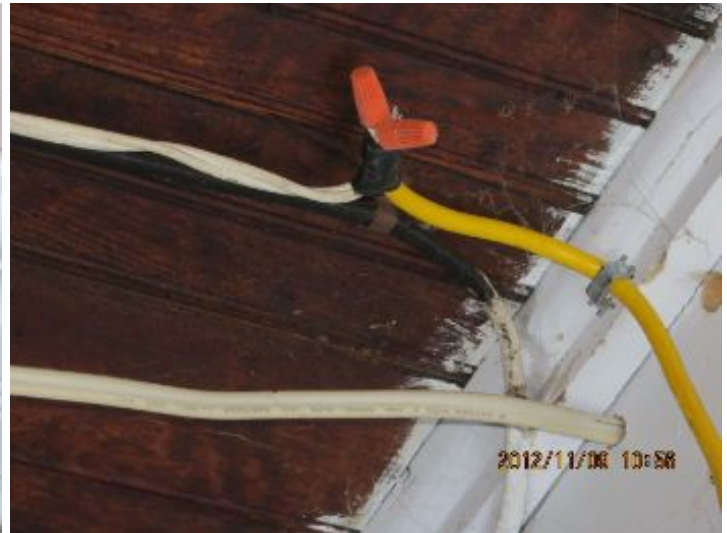
Improper use of extension cord observed. Extension cords should not be permanently installed or be routed through walls, floors or partitions.

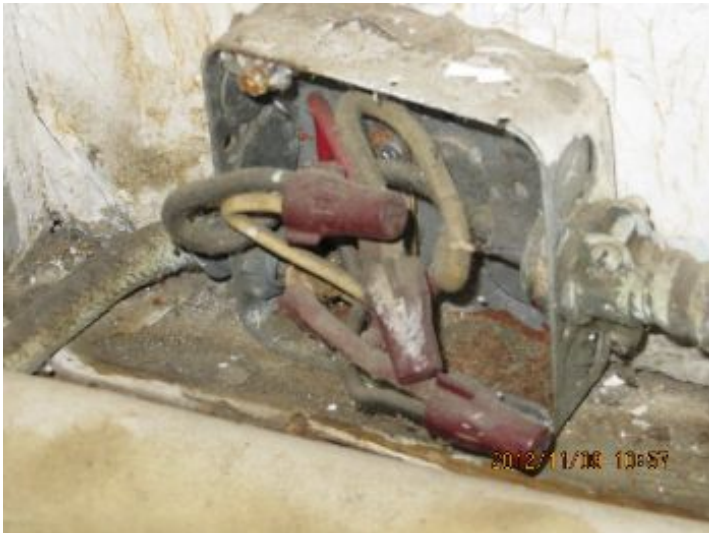
Missing cover plates observed, suggest installing for safety.

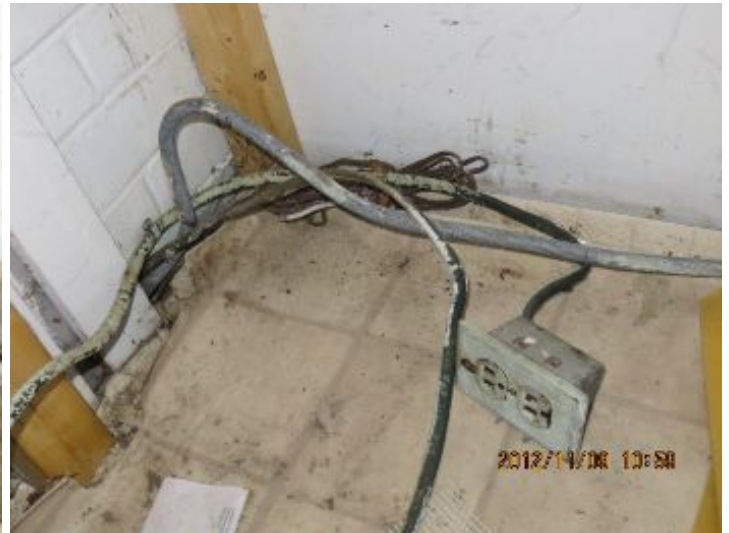
Exposed wires observed. Recommend review by a licensed electrician for repair or replacement, as necessary, prior to close.
