# ***New Trend Home Inspection Inc.***

## ***Home Inspection Report***

414 Anywhere St, Toronro

Inspection prepared for: John Doe  
Date of Inspection: 11/9/2012 Time: 10.00 am  
Age of Home: 80-100 Size: 2000

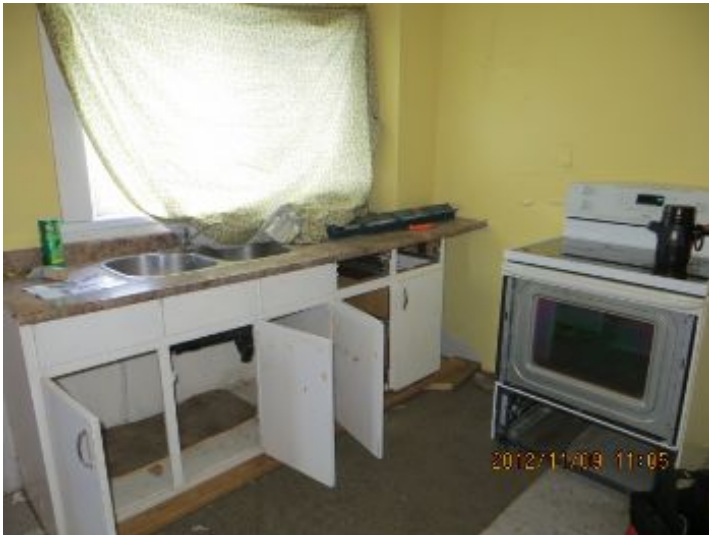
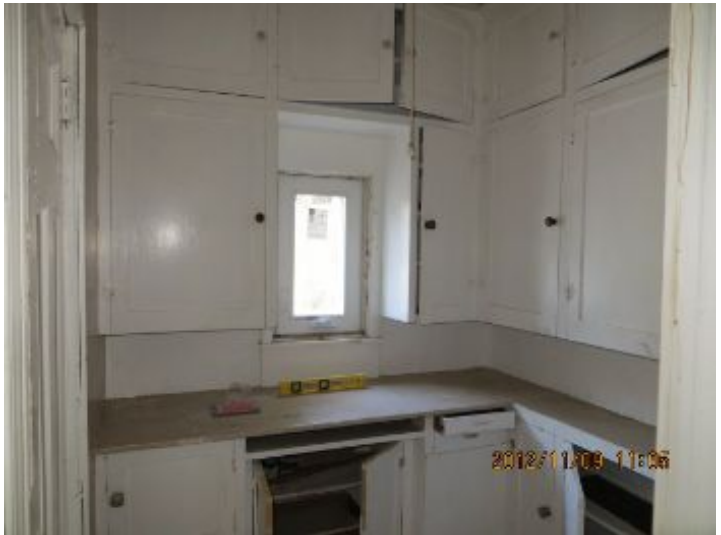
In the inspectors opinion the cabinets are near the end of their useful life due to

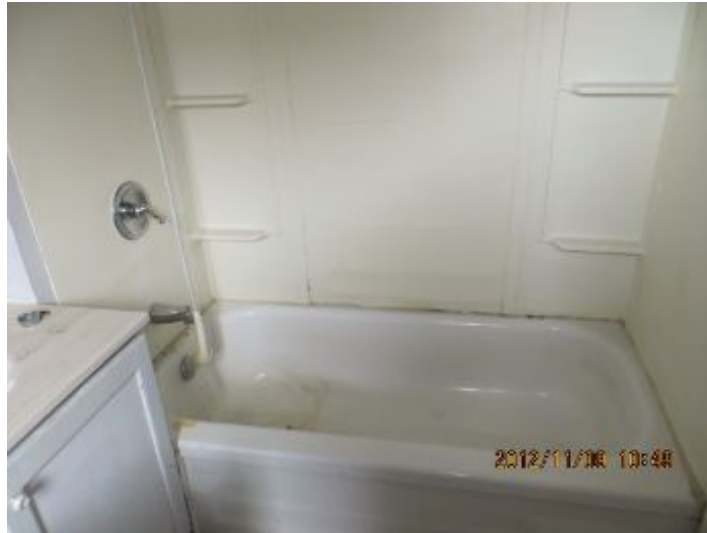
Routine caulking and maintenance where was marked also Suggest all tile edges and tub/shower walls be caulked and sealed to prevent moisture penetration. All missing/damaged grouting should be replaced. Failure to keep walls sealed can cause deterioration and extensive moisture damage to the interior walls and surrounding sub-flooring. This damage is not always visible or accessible to the inspector at the time of inspection.

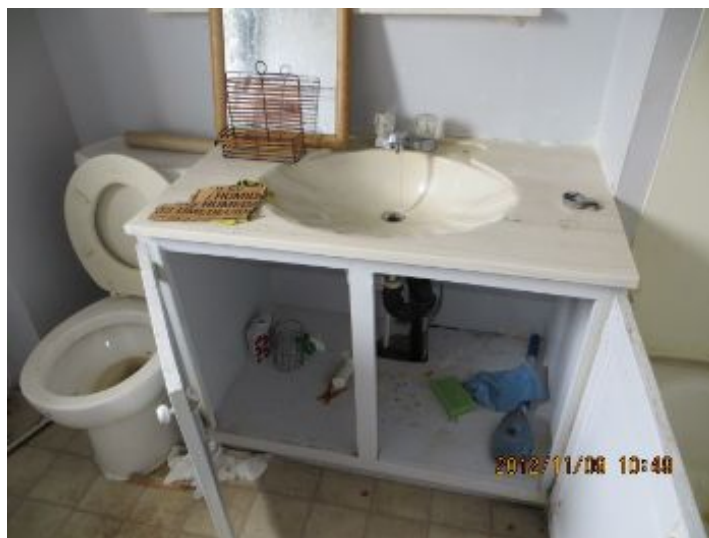
The bathroom is in marginal condition. Major remodeling is recommended in the near future.

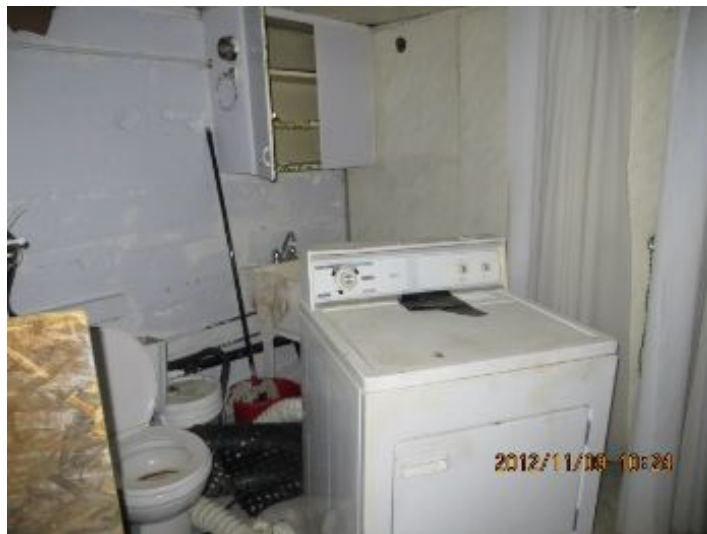
The bathroom is in marginal condition. Major remodeling is recommended in the near future.(Not functional)
