# ***New Trend Home Inspection Inc.***

## ***Home Inspection Report***

414 Anywhere St, Toronro

Inspection prepared for: John Doe  
Date of Inspection: 11/9/2012 Time: 10.00 am  
Age of Home: 80-100 Size: 2000

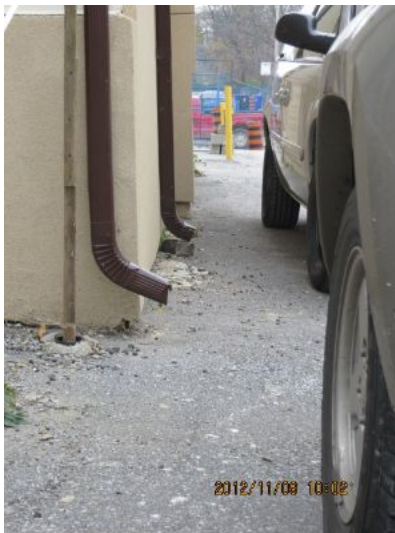
Extending all downspout(s) 4'-6' away from building.(All around the House)

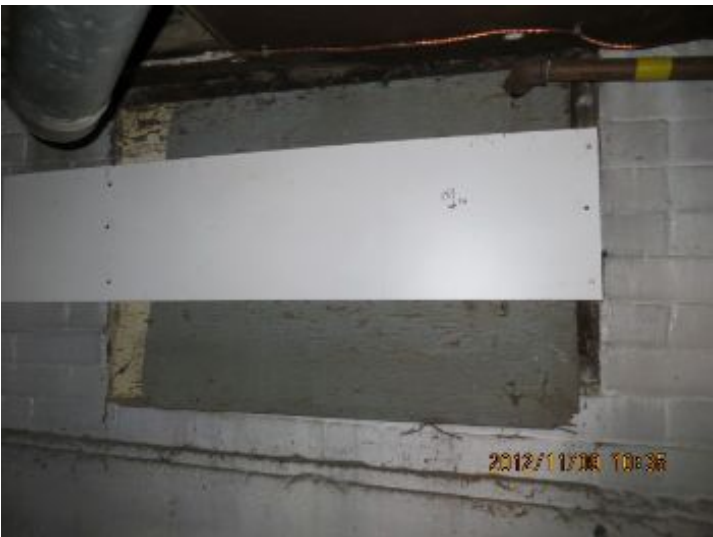
Some or all windows were blocked with materials or storage. Has to be open.

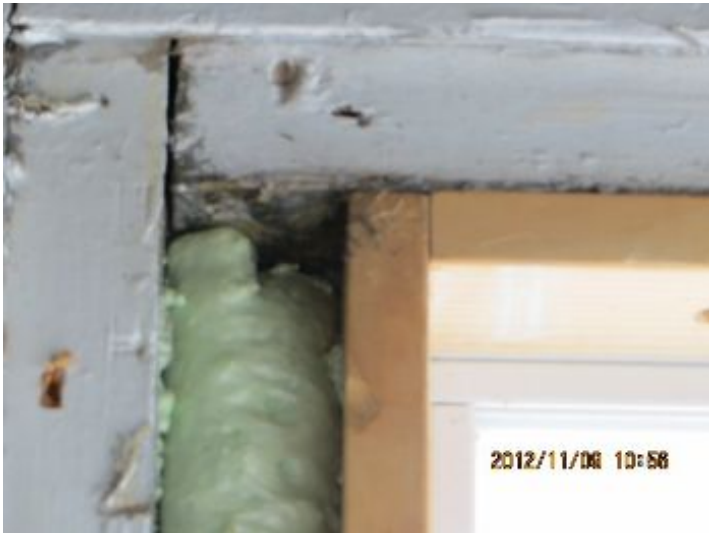
Exterior wall(s) have been cut or bored. The exterior wall is not structurally supported. Installation proper lintel is required.

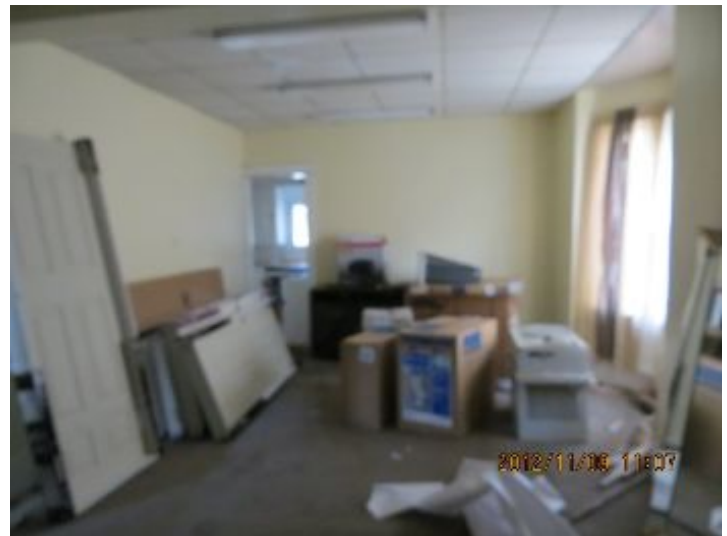
Interior Walls Condition

Damage(s) noted. required repair and painting.

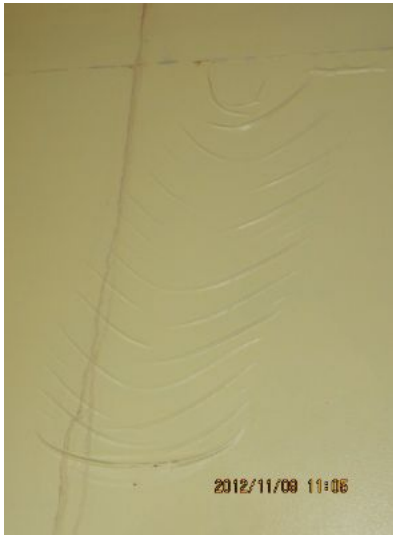
Evidence of past water penetration observed.

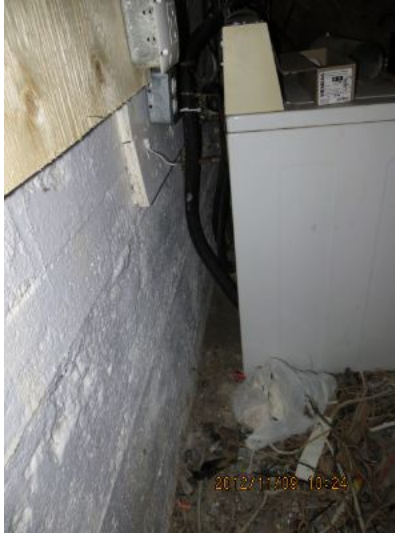
Dryer is not hooked up
