# ***New Trend Home Inspection Inc.***

## ***Home Inspection Report***

414 Anywhere St, Toronro

Inspection prepared for: John Doe  
Date of Inspection: 11/9/2012 Time: 10.00 am  
Age of Home: 80-100 Size: 2000

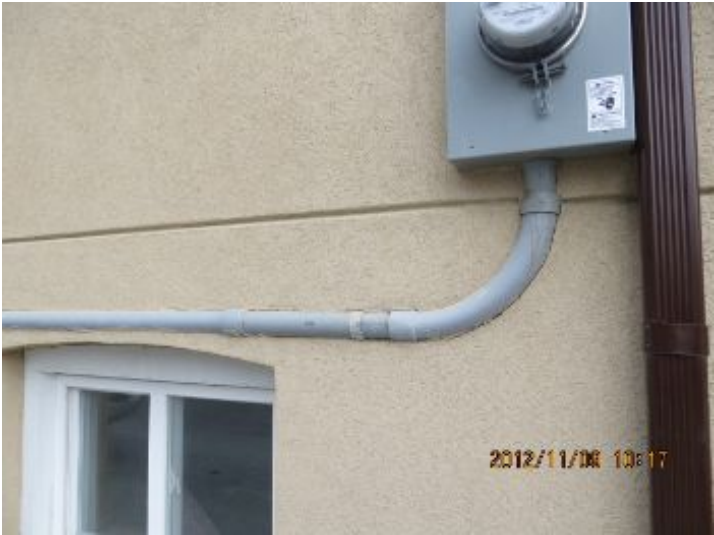
- Recommend review by a qualified professional electrician for repair or replacement as necessary.
- Open ground in some receptacles is noted. At: Most of plugs.
- Exposed connection, missing splice cover observed at masthead. Suggest contacting the local electric utility company for repair, as necessary, for safety.

Recommend review by a qualified professional electrician for repair or replacement as necessary.

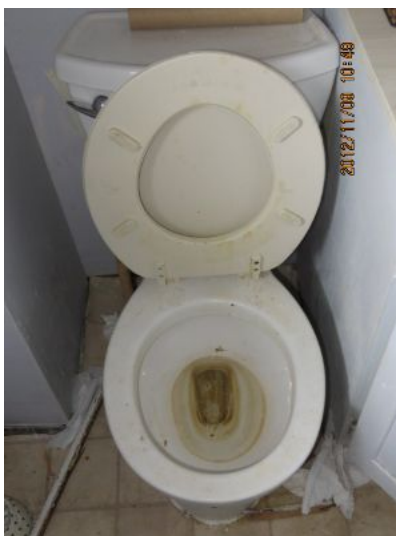
Toilet is old. Replacing the toilet is recommended.
